## **Expert Witness Report**

Gerald S. Nielsen  
Ocean Ridge Maritime Consulting LLC

No. 2:21-CV-965

UNITED STATES DISTRICT COURT FOR THE DISTRICT OF  
SOUTH CAROLINA  
CHARLESTON DIVISION IN ADMIRALTY

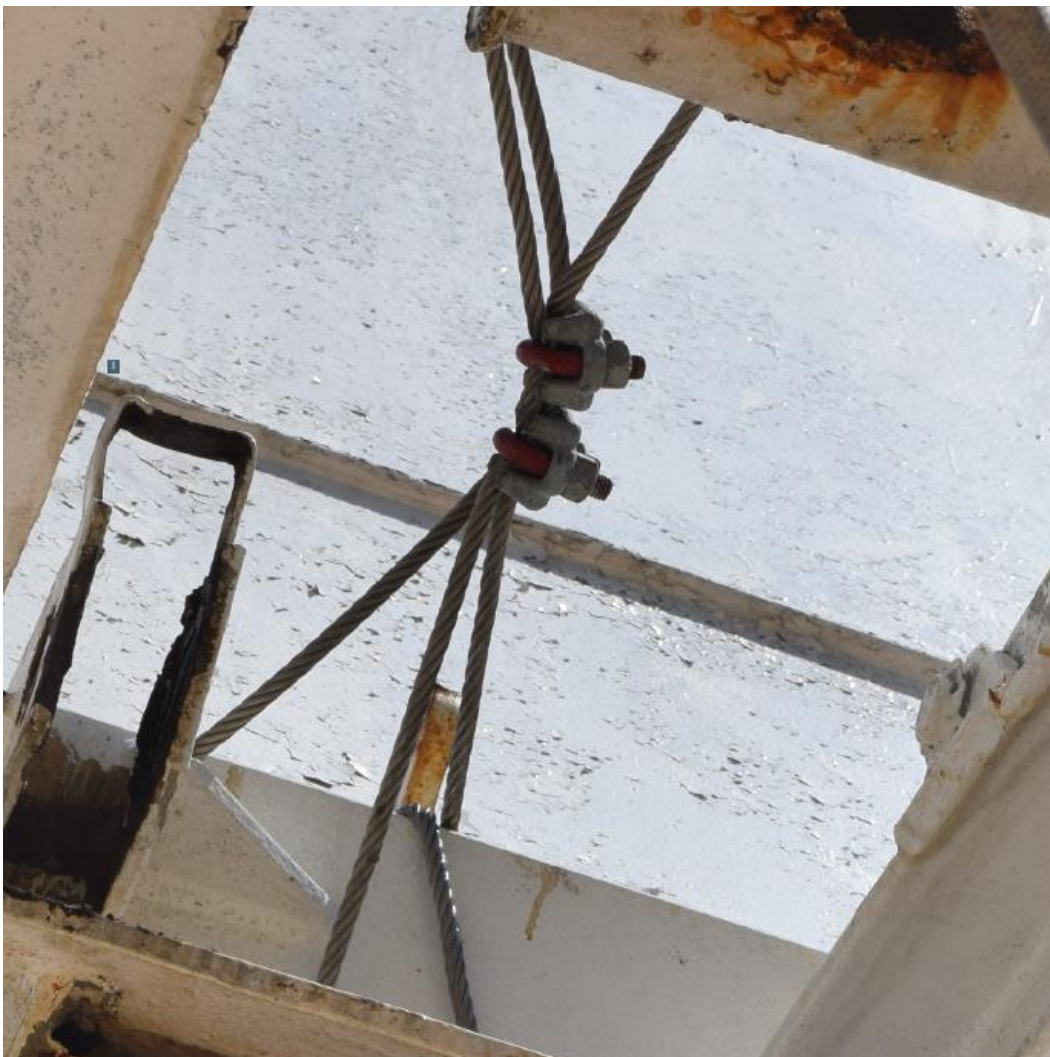
During the response the DSI Safety Office contacted the local OSHA office and advised them of a fatality. The OSHA report<sup>15</sup>, issued 6 September 2019, concluded that the wire rope used to secure the davit arm in the raised position failed as a result of an electrical current passing through it where it made contact with the davit arm around a sharp corner without relief or protection.

In addition to improper use of wire rope clips, DSI also violated OSHA<sup>23</sup> by having the wire rope in direct contact with the davit corners and wrapped in such a way that resulted in sharp bends. The use of wooden blocks or other suitable protective material as a buffer between the wire rope and the davit both protects the wire rope from damage and electrically insulates the

The following photo excerpt<sup>25</sup> from the USNS *Lummas* shows improper wire rope clip installation with two clips instead of the required six, clamping three wires (instead of the allowed maximum of two) with improper wire rope clip orientation and spacing, and where the wire rope is installed around a sharp corner bend without protection from electrical currents or damage. This rigging is in clear violation of OSHA standards 1915.112(b)(2) and 1915.116(f), manufacturer's instructions, and good rigging practice:
